Technical Note N-1284

ANALYSIS OF THE CONDITION OF ECHO TOWER,  
AZORES FIXED ACOUSTIC RANGE, AFTER ONE  
YEAR AT 1500 FEET OF DEPTH

May 1973

Naval Civil Engineering Laboratory  
Port Hueneme, California 93043

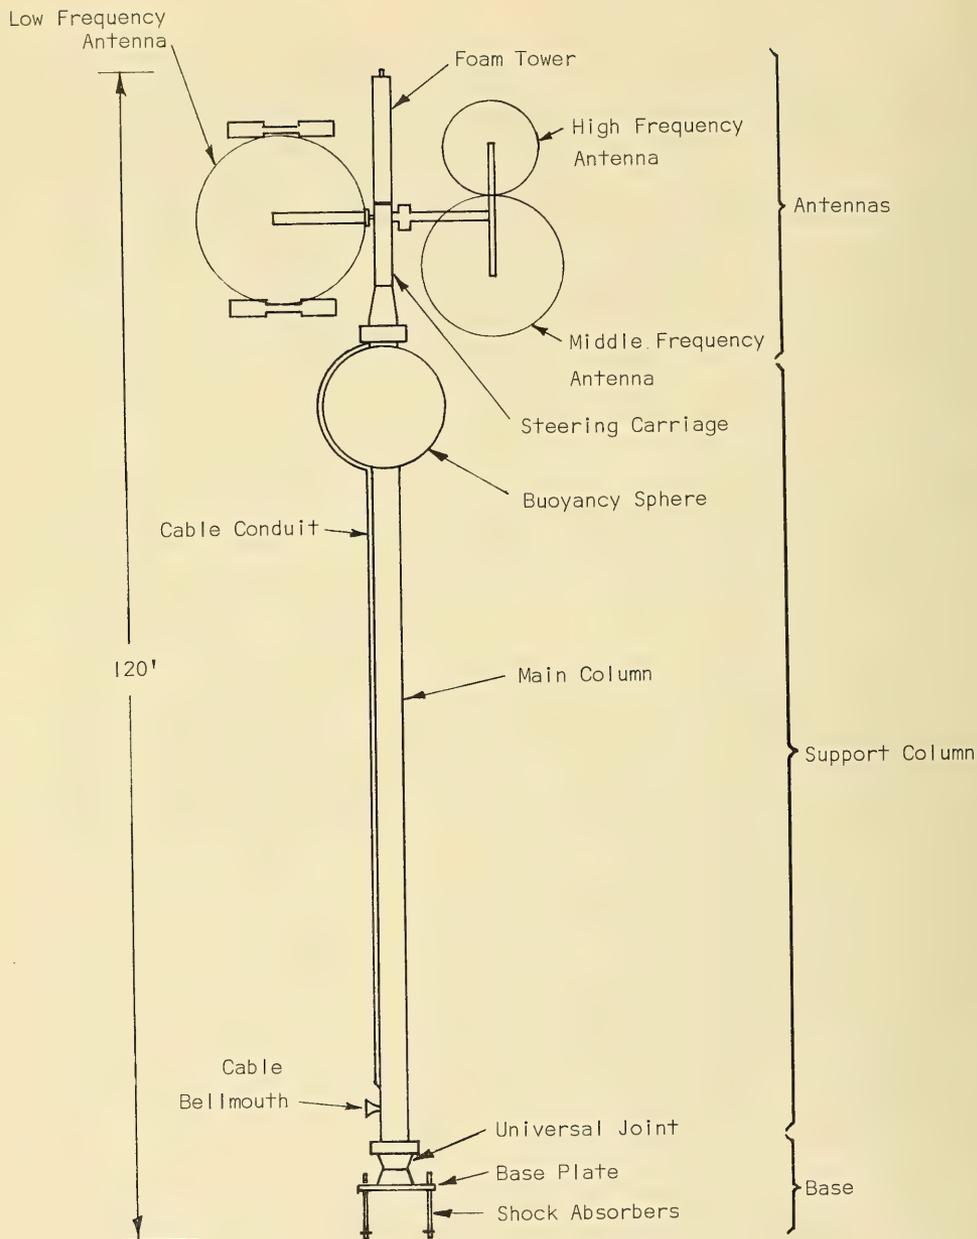
Figure 1. Sketch of Tower.

Approximately 12 hours after being retrieved from depth, an inspection of the upper portion of the tower was made while the tower was still completely submerged in seawater. A sketch of the tower is shown in Figure 1. Depth limitations limited this inspection to the portion of the tower above the center line of the sphere.

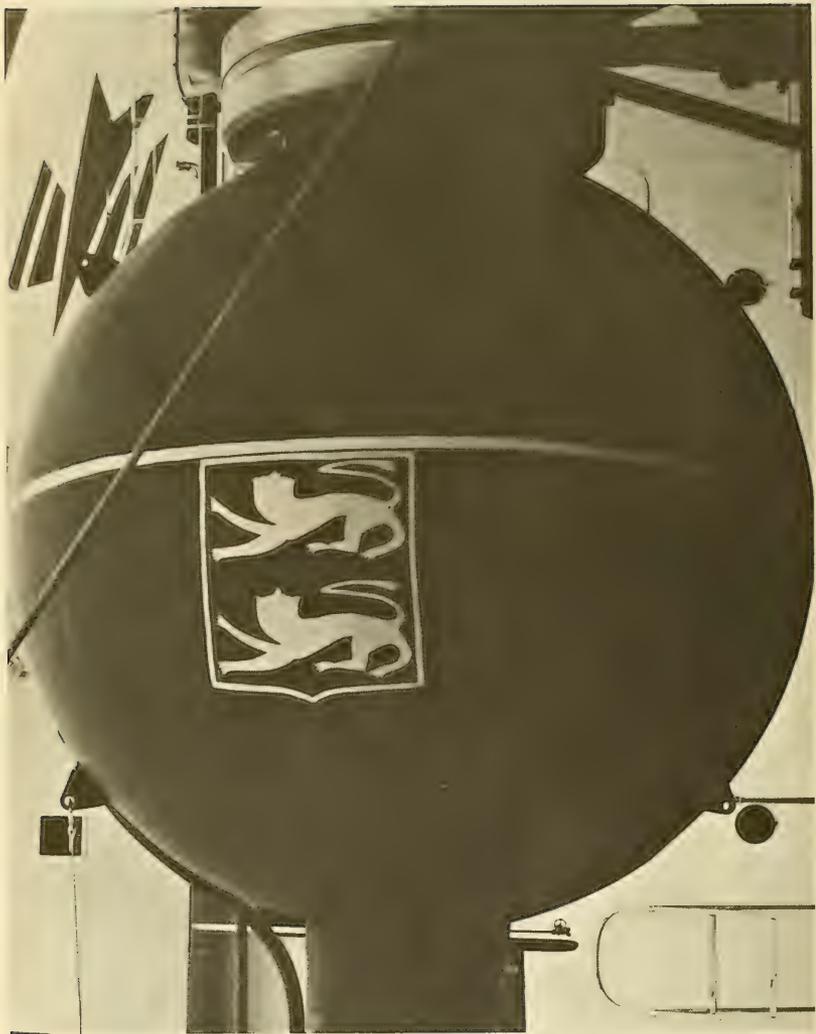
Figure 18. Buoyancy sphere after recoating.

Echo tower was to be reemplaced if its condition permitted. As the damage resulting from emplacement and retrieval was minimal and the amount of corrosion found did not preclude reemplacement, the tower was repaired. The four shock absorbers were replaced with similar units. However, the tips on these units were screwed into place in contrast to the pressed-in units originally used. These screwed-in tips were further secured by welding and are shown in Figure 17. The universal joint was relubricated. The tower base, universal joint, main column and buoyancy sphere were cleaned by an air powered high pressure water jet and recoated with a copper oxide-pigmented rubber-based antifouling topcoat. The yellow enamel identifying marks were reapplied after the antifouling coat had cured. The condition of the buoyancy sphere after repair is shown in Figure 18. The fasteners used to secure the cable conduit to the main column were recoated as required with a rubber based sealing compound. Rusted areas on the steering carriage and antenna support arms were cleaned and recoated with a two coat, polyamide-cured epoxy paint system. The gas generators were replaced. The attacked areas on the antennas were carefully sanded and cleaned before recoating with the same paint system. The gas connections between the ends of the compliant tubes and the gas manifolds were cleaned, the clamps and tubing replaced as necessary and recoated with a two component sealing compound where any rust staining of the connections was noted. Areas of paint failure on the foam tower were repaired using the topcoat of the polyamide cured epoxy paint system. Identifying marks were reapplied to the foam tower. The recoated foam tower is shown in Figure 19. The main lifting eye was cleaned, and then recoated with the two coat polyamide cured epoxy system. The tower was then considered to be ready for reemplacement.

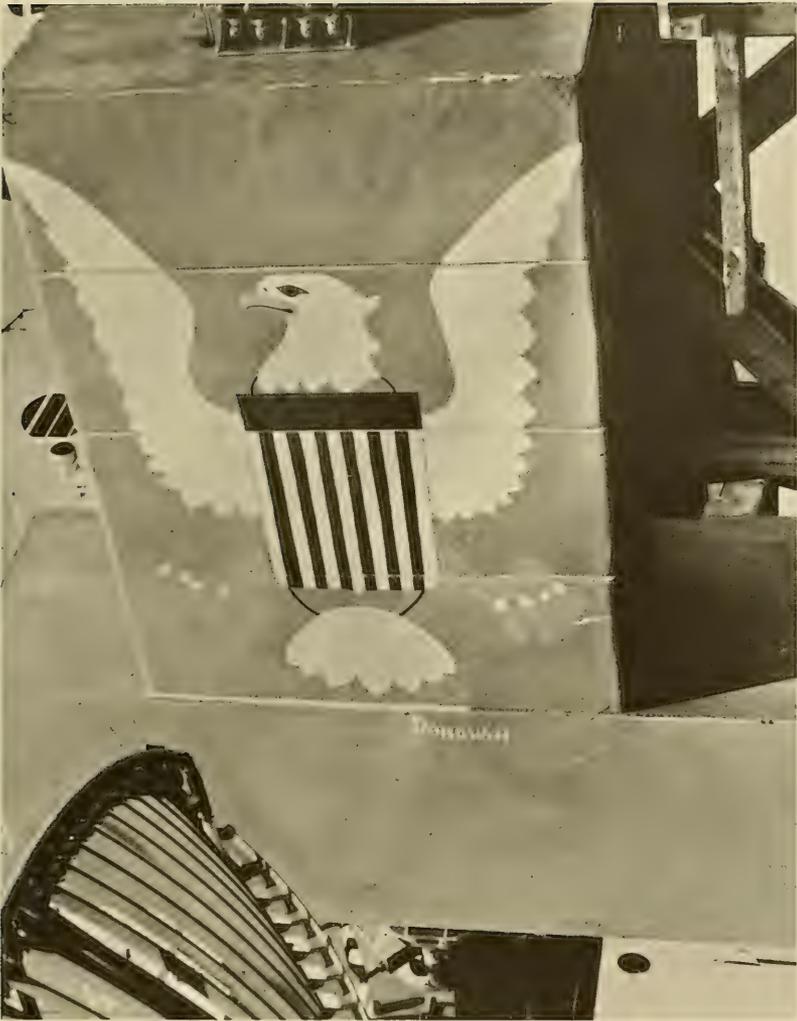
Figure 19. Foam tower after recoating.
